Border Mitigation Flood Control for Binational Hazards

Alejandro Riano, M.Sc., P.E., CFM

Project Information

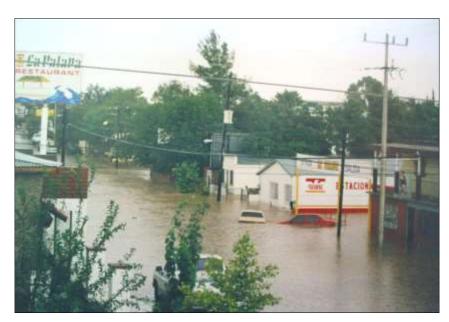
Recurring flooding in Agua Prieta, qualified as a 10-year event

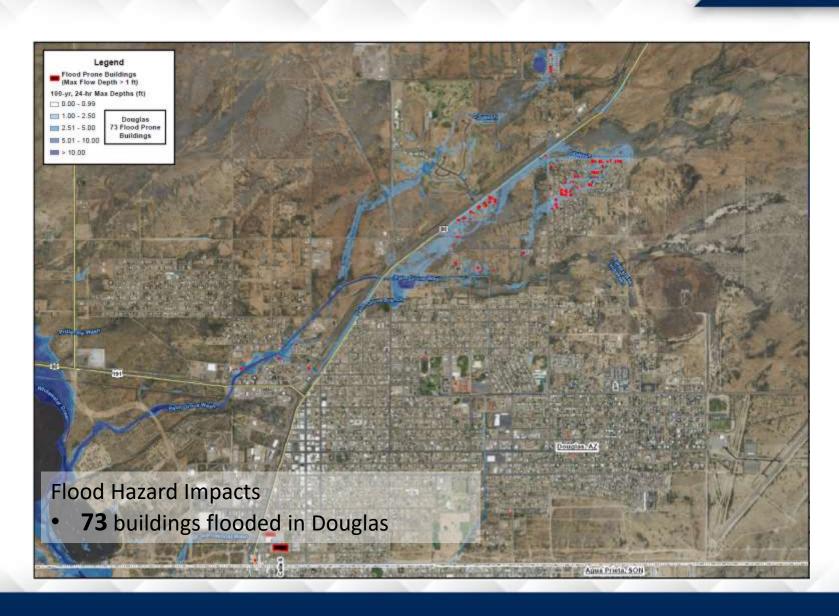
Flood Hazard Areas in Douglas, Arizona

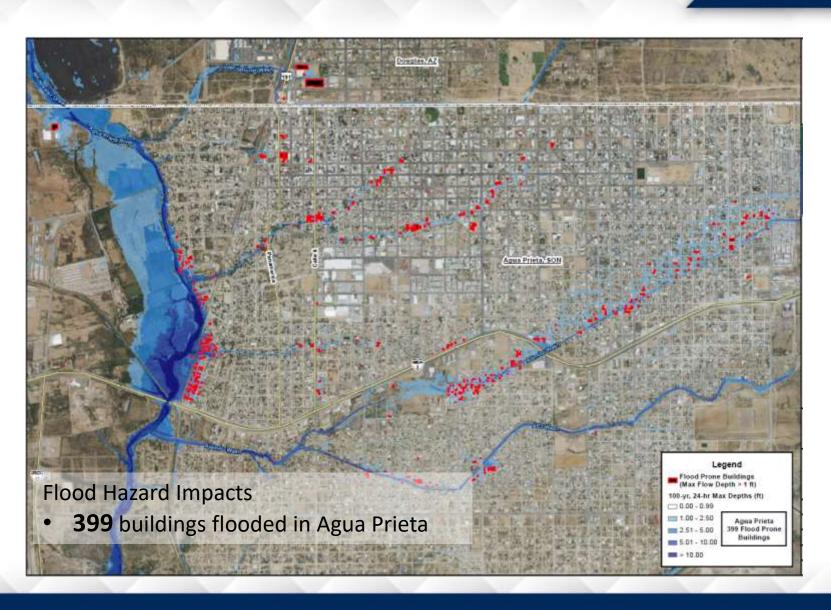
Flood Hazard Areas in Agua Prieta, Sonora

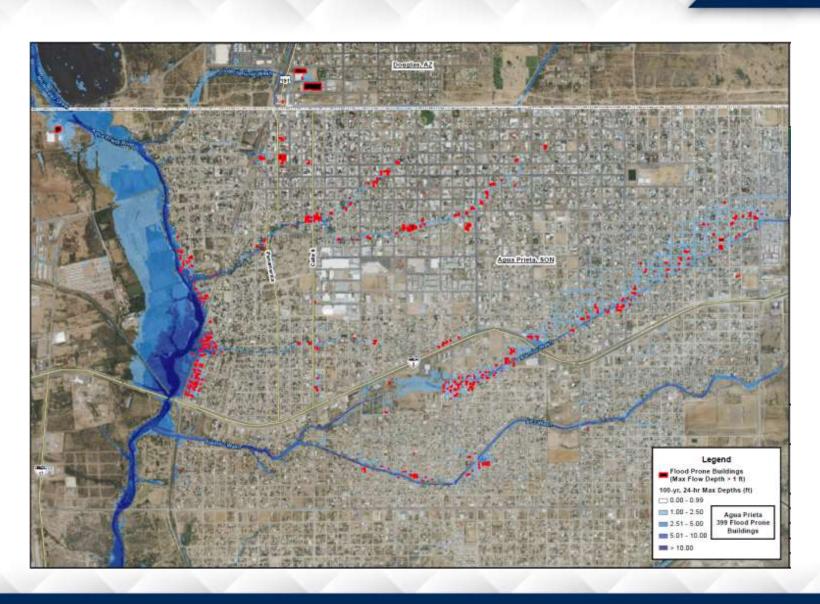
Flood Hazard Areas in Agua Prieta, Sonora

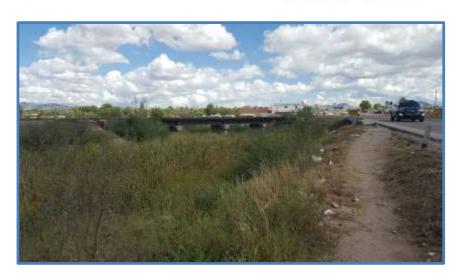
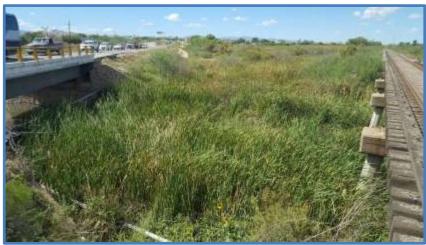
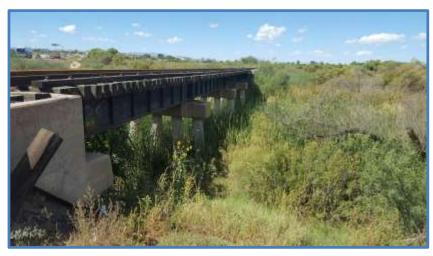
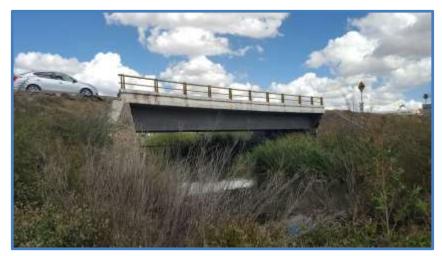
Agua Prieta River Constrained Crossing

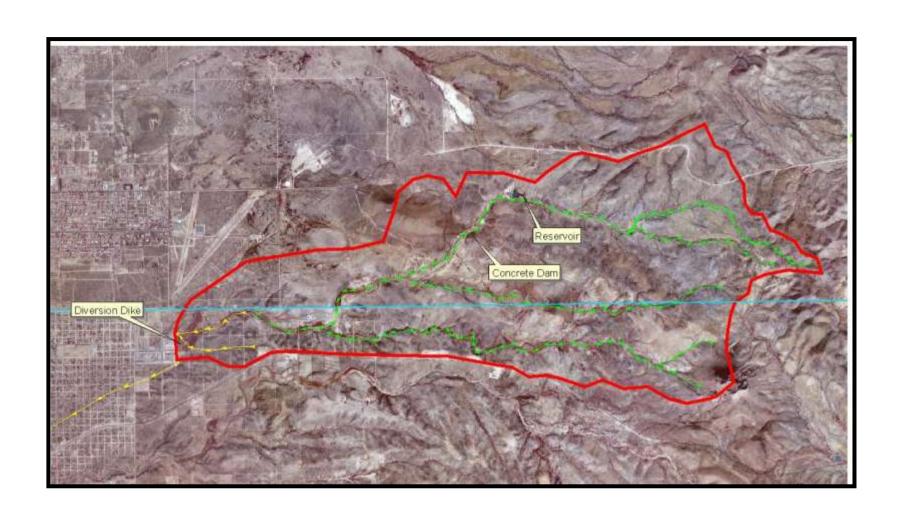
Alamito Wash Basin

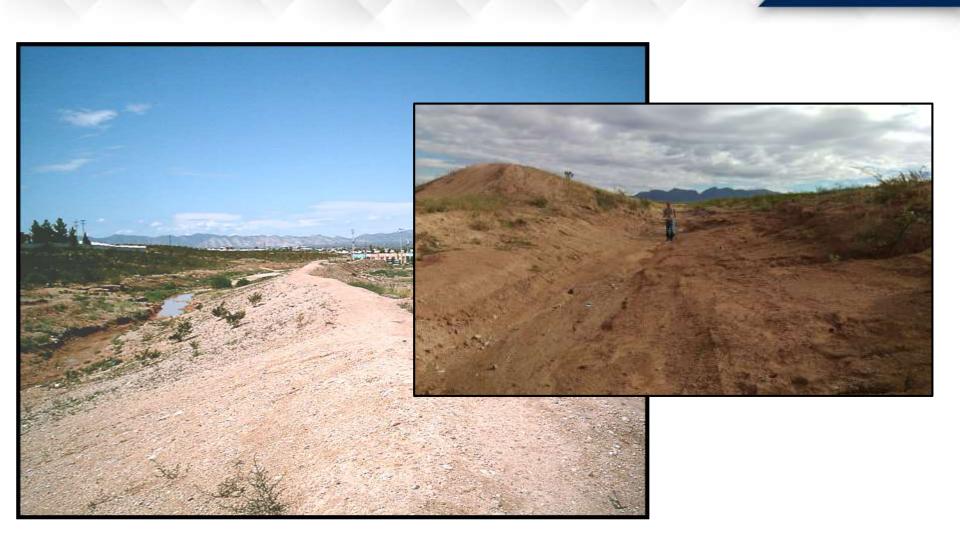
Alamito Wash

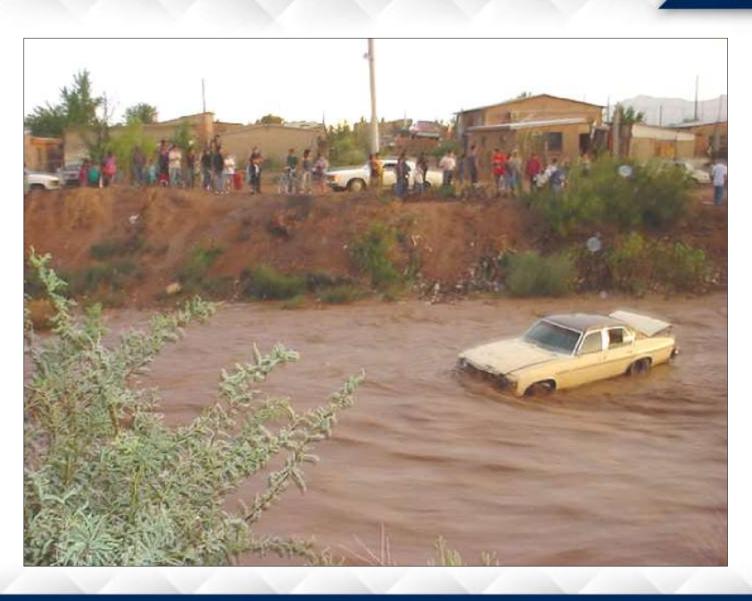
2-Year Event Flooding

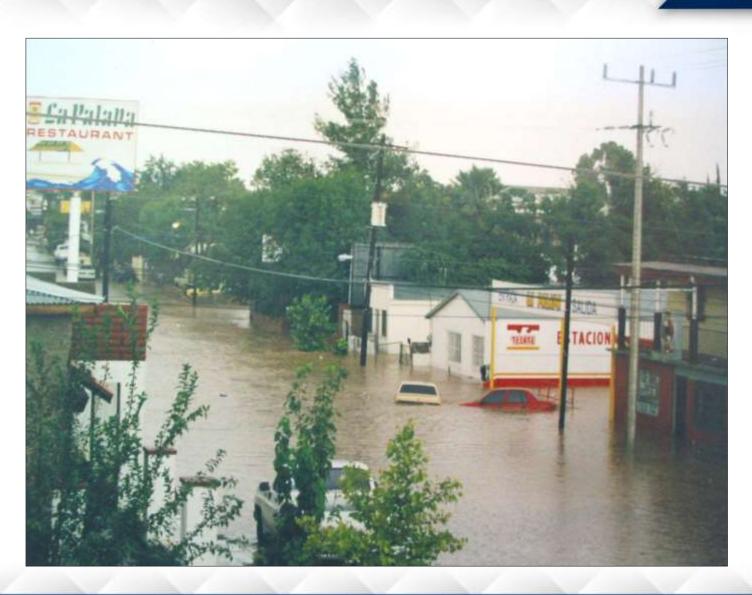
10-Year Event Flooding

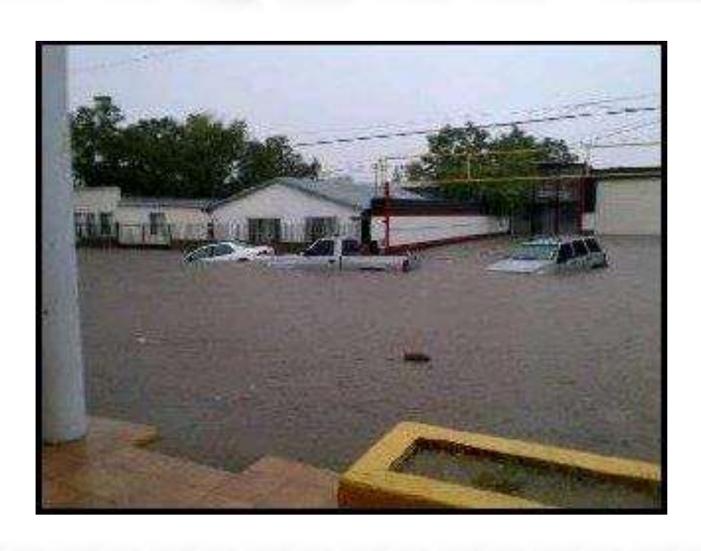
Agua Prieta Flooding in 2012

- Existing channels with lack of conveyance
- Undersized infrastructure
- Shortduration/fastoccurring events

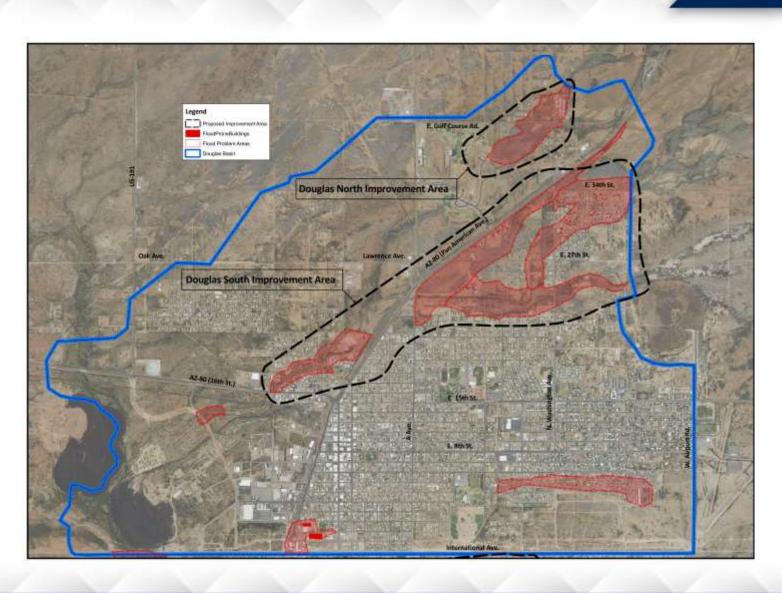
Improvement Areas – Douglas

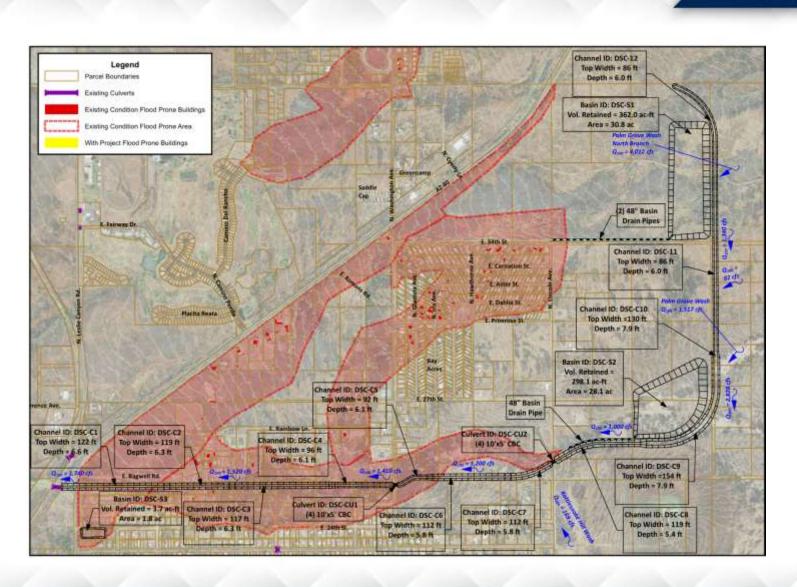
Douglas Recommended Alternative

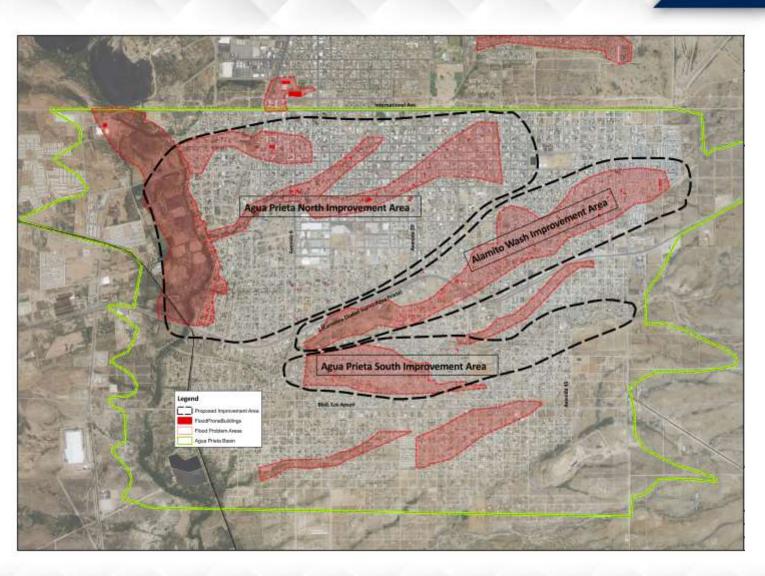
Improvement Areas – Agua Prieta

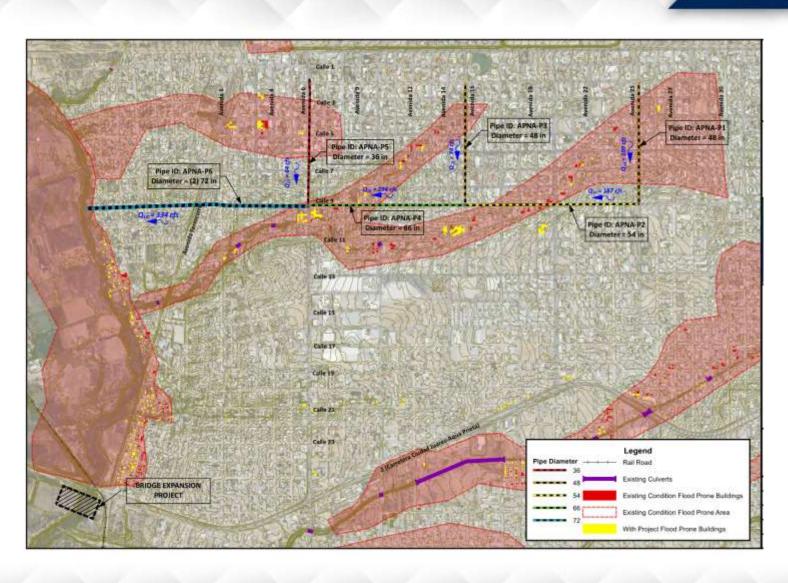
Agua Prieta - North Recommended Alternative

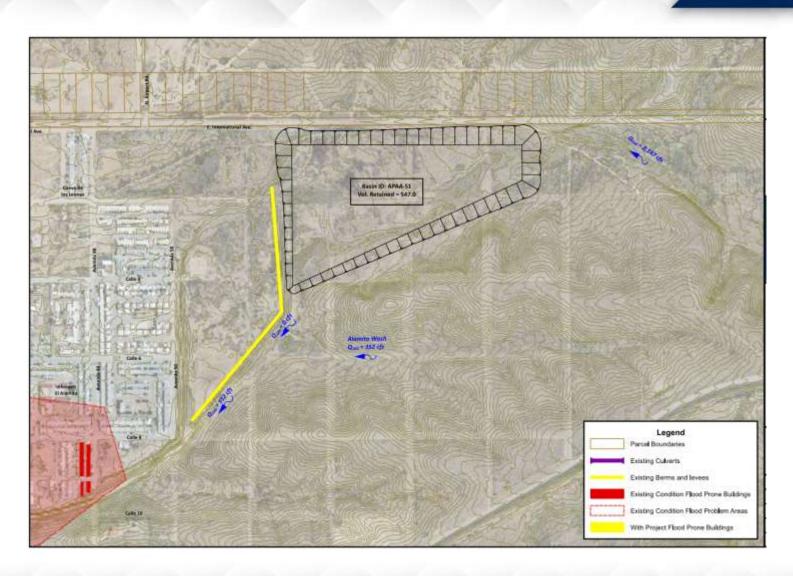
Alamito Recommended Alternative

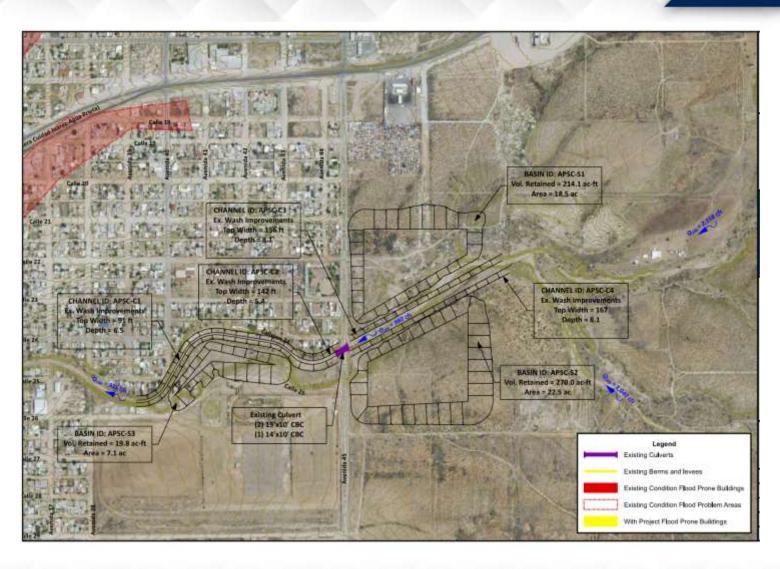
Agua Prieta - South Recommended Alternative

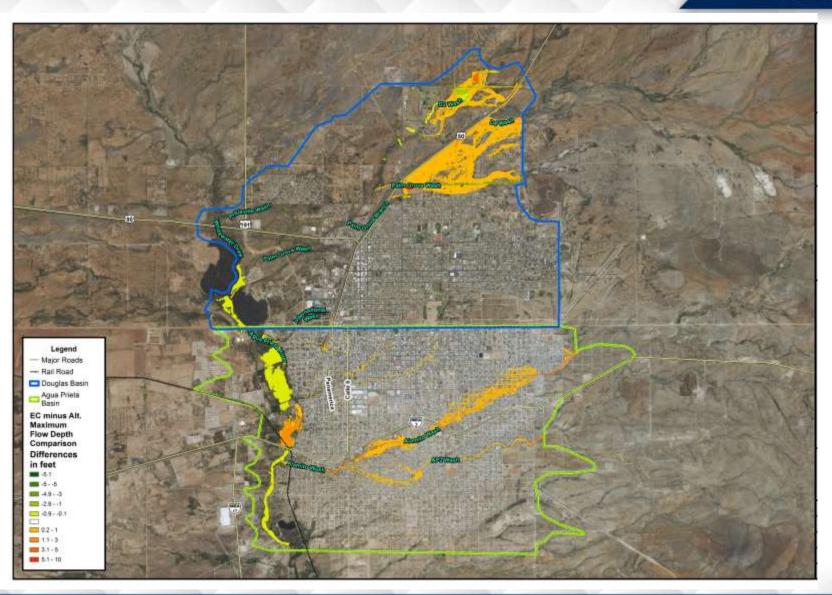
Flood Hazard Mitigation Alternatives (2-year)

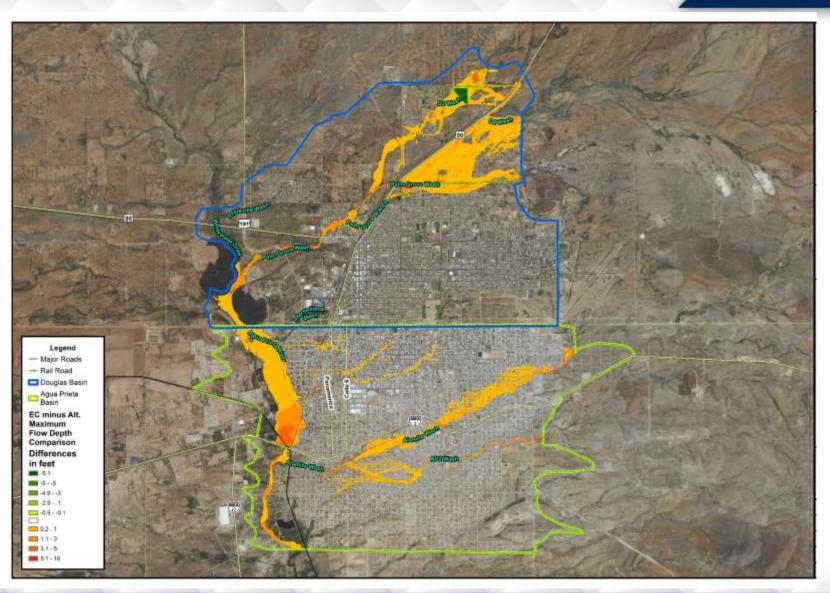
Flood Hazard Mitigation Alternatives (10-year)

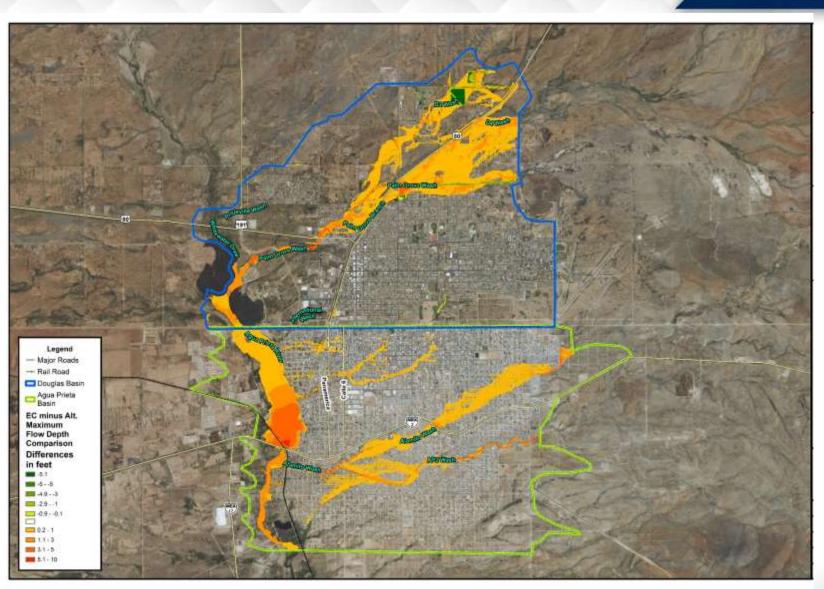
Flood Hazard Mitigation Alternatives (100-year)

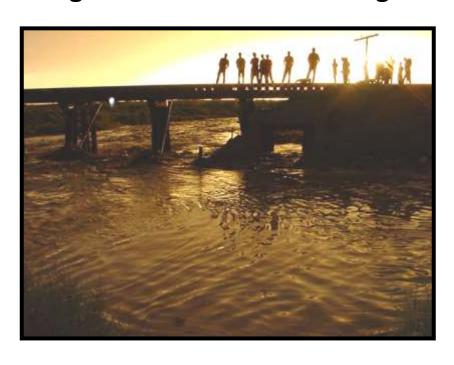
Agua Prieta River Flooding
