*Association of State Floodplain Managers*  
*2018 Conference*  
*Phoenix, Arizona*

# **Re-delineation for Two Alluvial Fans in Scottsdale and Phoenix Maricopa County, Arizona**

**Re-analysis of Alluvial Fans No. 5 and No. 6 in Scottsdale and Phoenix, Maricopa County, Arizona Based on 2003 FEMA Alluvial Fan Guidelines, Shimin Li and Bing Zhao, FCDMC, 2014.**

**Pinnacle Peak West Area Drainage Master Study: Fans 5 and 6 Floodplain Redelineation Study, JE Fuller Hydrology & Geomorphology, Inc., October 2017**

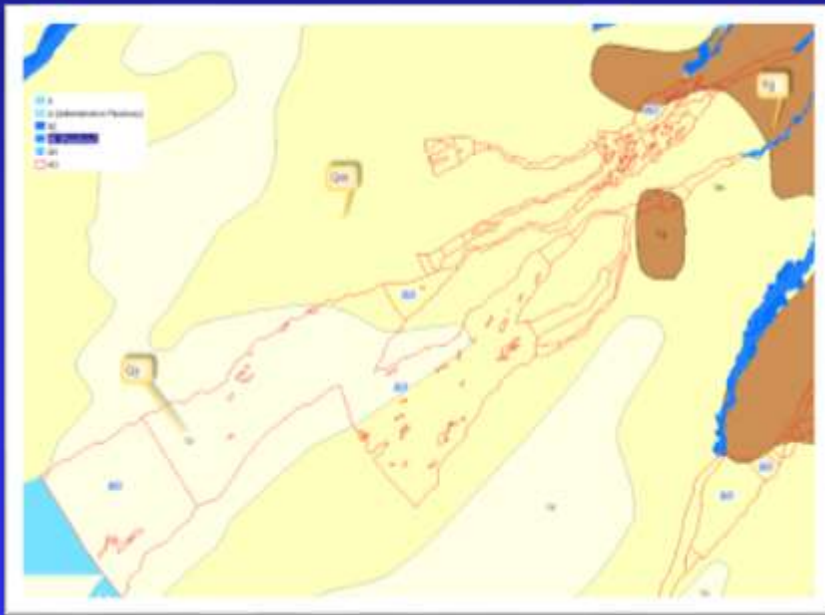
## AZGS Geologic Map

**Qy: Holocene Surficial Deposits (0-10 ka). Unconsolidated deposits associated with modern fluvial systems.**

**Qm: Late and Middle Pleistocene Surficial Deposits (10 – 750 ka). Unconsolidated to weakly consolidated alluvial fan, terrace, and basin-floor deposits with moderate to strong soil development.**

**Composition requirement is met.**

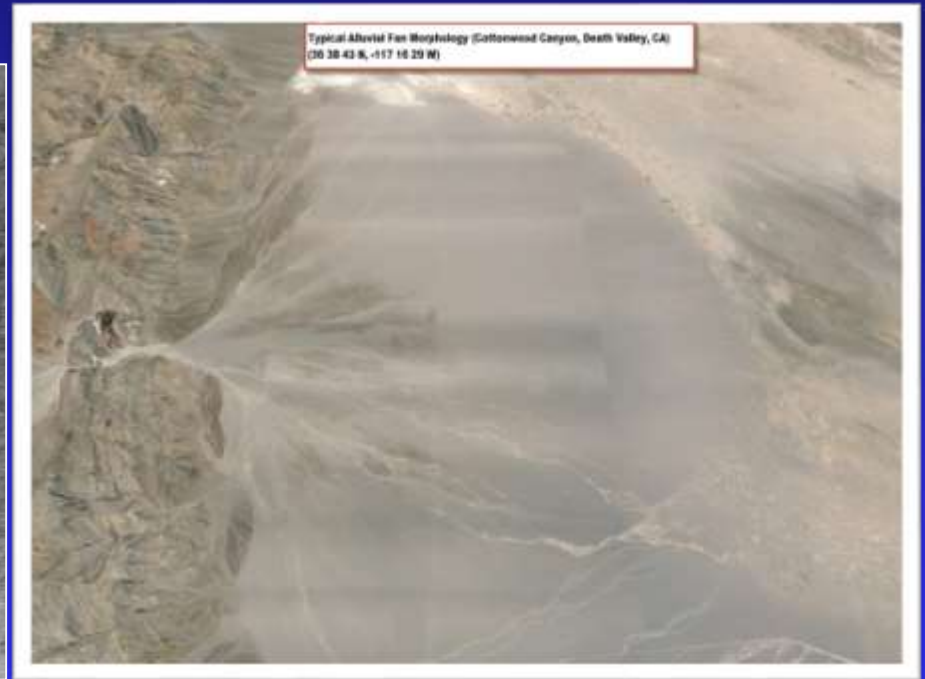
1953 Aerial Photo

Typical alluvial fan morphology

**Fan 5 and Fan 6 do not have typical alluvial fan landform morphology.**

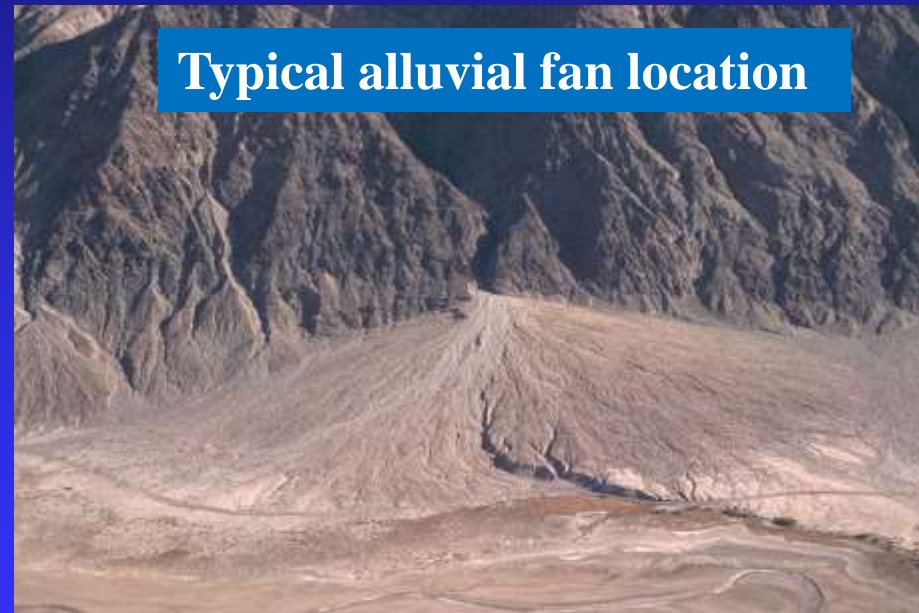
Alluvial fan landforms are located at a topographic break where long-term channel migration and sediment accumulation become markedly less confined than upstream of the break. This locus of increased channel migration and sedimentation is referred to as the alluvial fan apex

**There is no typical topographic apex for Fan 5 or Fan 6.**

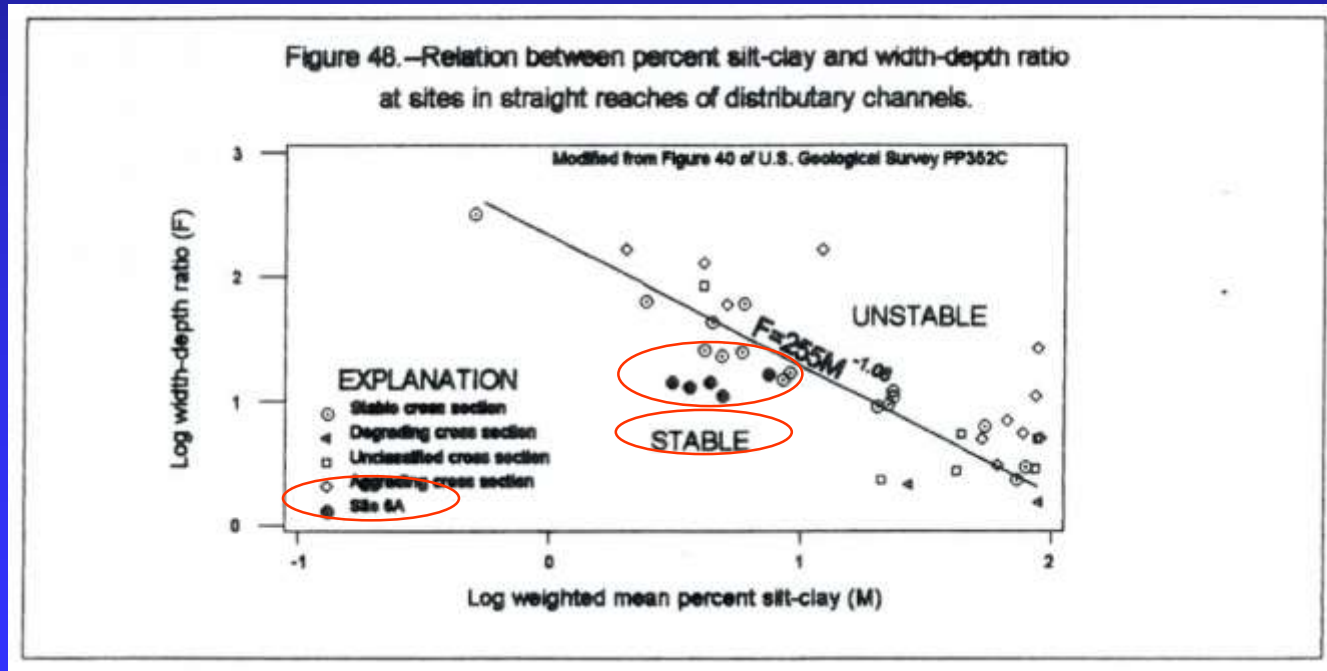
Data from **measurements of channel geometry** and **material samples** at several cross sections were plotted on the **relation between channel width-depth ratio and percent silt-clay** along the wetted perimeter published in USGS Professional Paper 352C; and the data for **site 6A** plotted consistently in the **stable region** of the relation.
