WATER

Sioux City's Ravine Park Watershed-Scale Stormwater Improvements with Innovative Funding

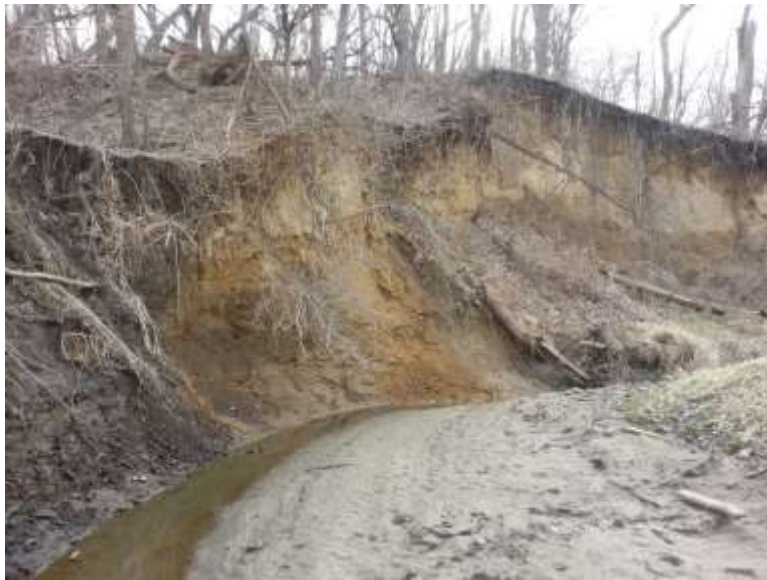
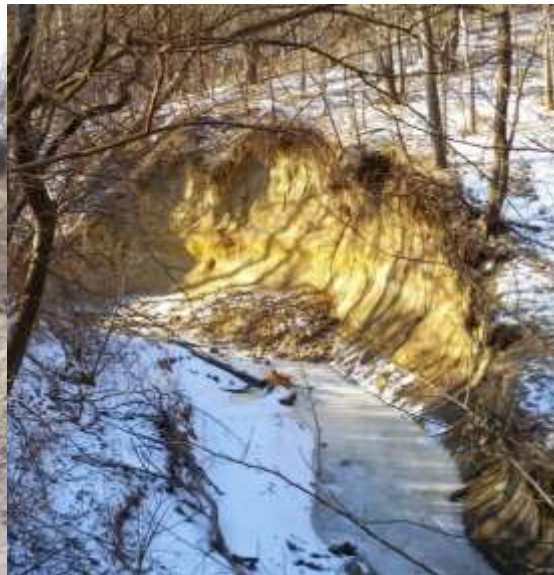
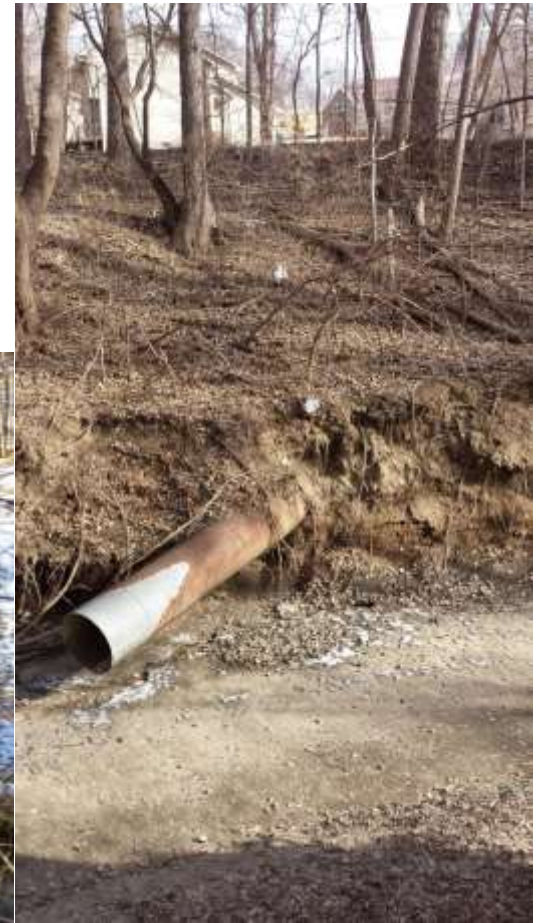
BIG PICTURE -SYMPTOMS

- Urban stream seems to be eating its banks
- Trees and storm pipes are washing downstream
- Banks are moving toward roads, infrastructure, etc.
- Property owners are losing yards, fences, sheds

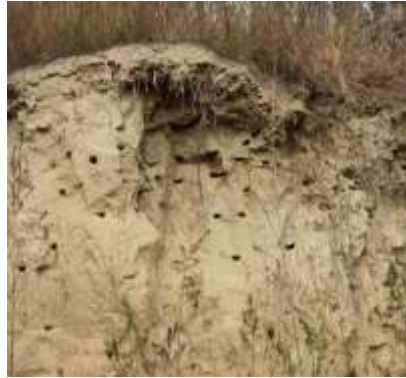
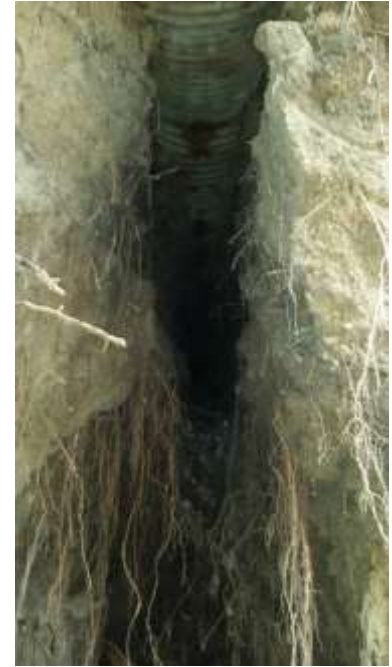
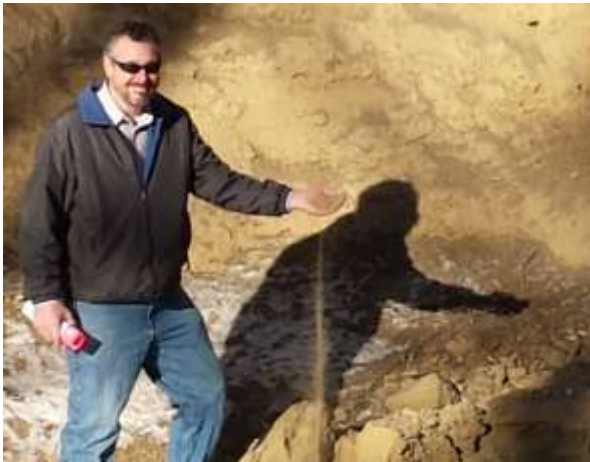
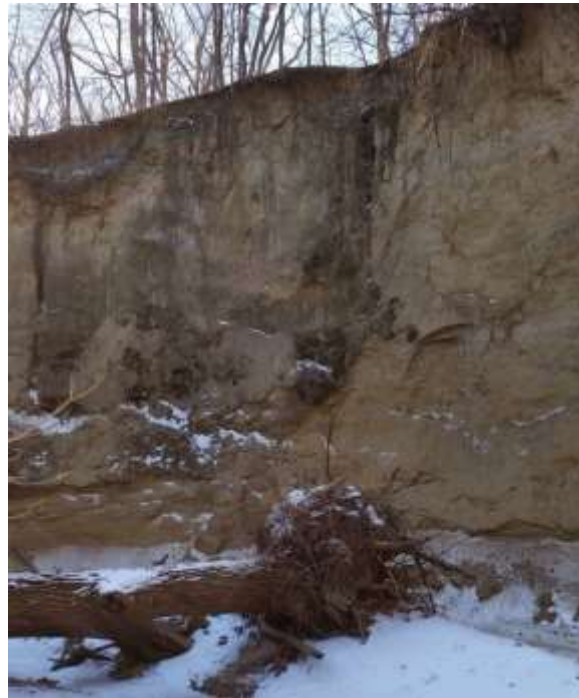
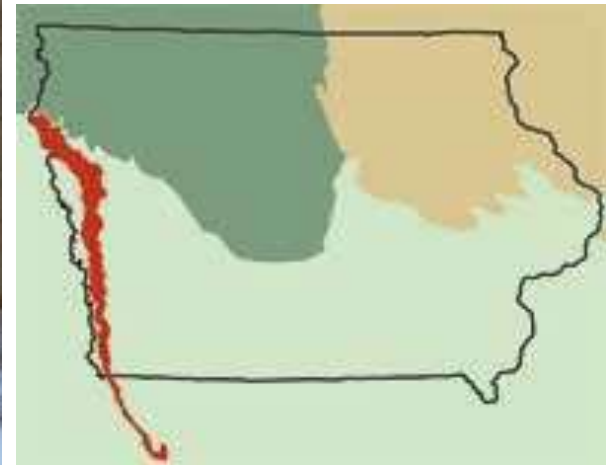
BIG PICTURE -LOESS

- Wind-blown glacier dust
- Dry loess = concrete
- Wet loess = pudding

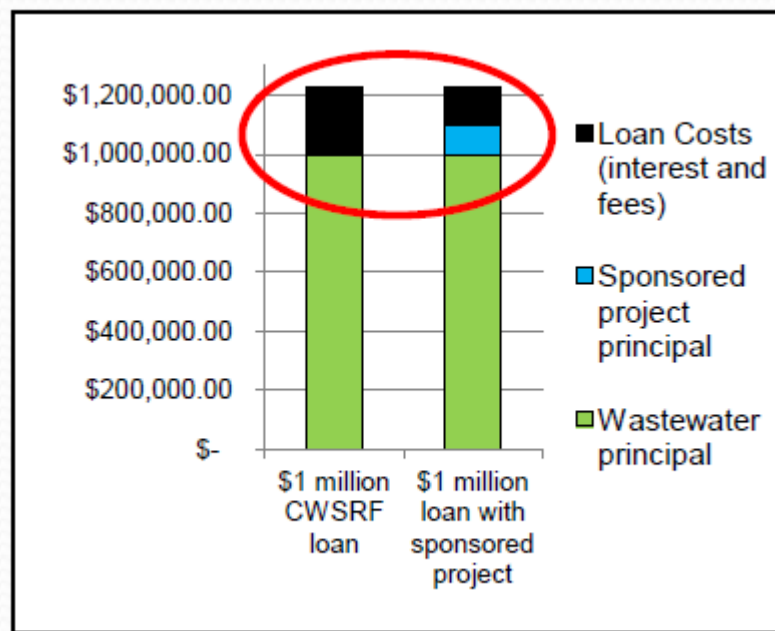
Typical Loan
Utility borrows principal for wastewater infrastructure and repays principal plus interest and fees

Loan with SP
Utility borrows principal for both wastewater infrastructure and sponsored project, but interest rate is reduced

Utility is able to finance **TWO** water quality projects for the cost of **ONE**

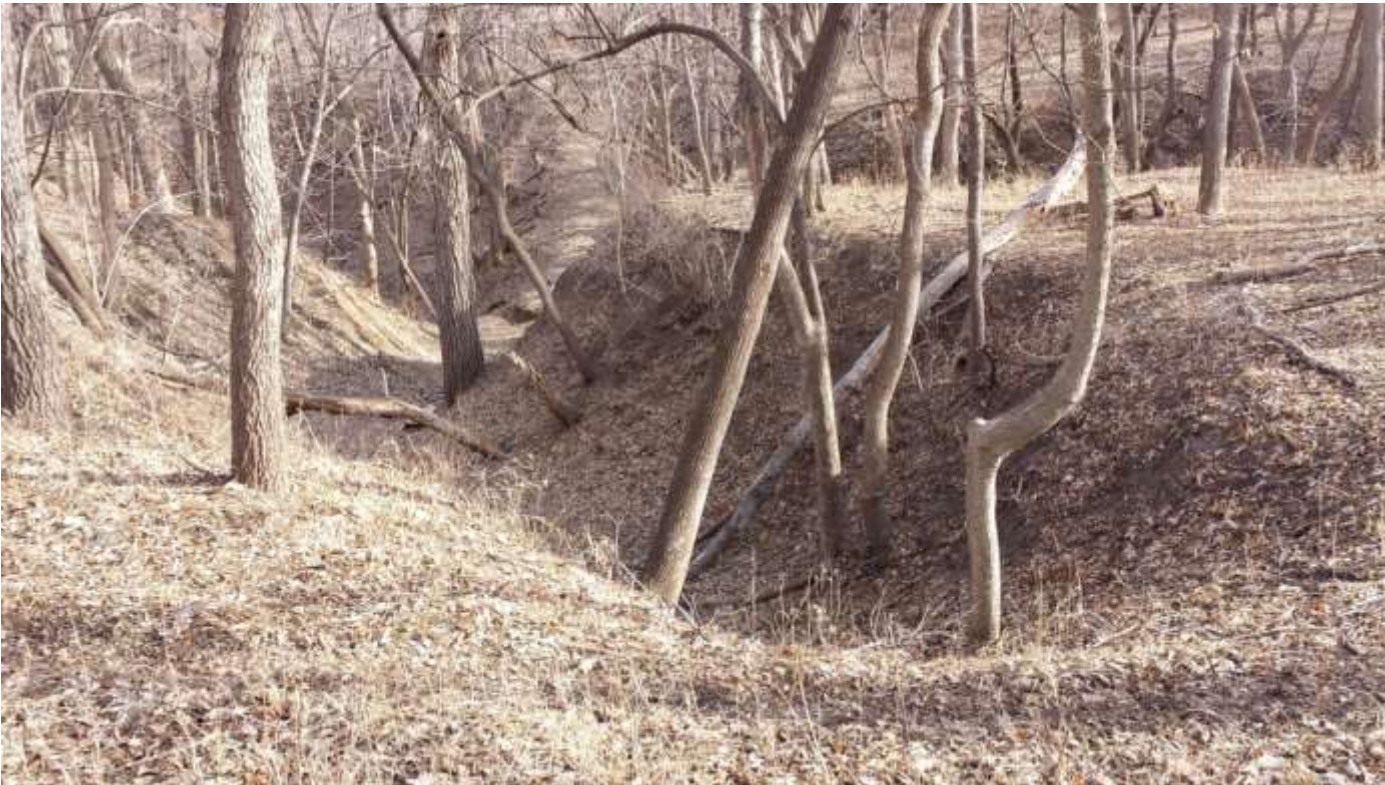
- Arrested head cuts
